HydroFLOW Case Study - Kentucky Distillery

Cooling tower and Dephlegmator (Heat Exchanger) - January 2023

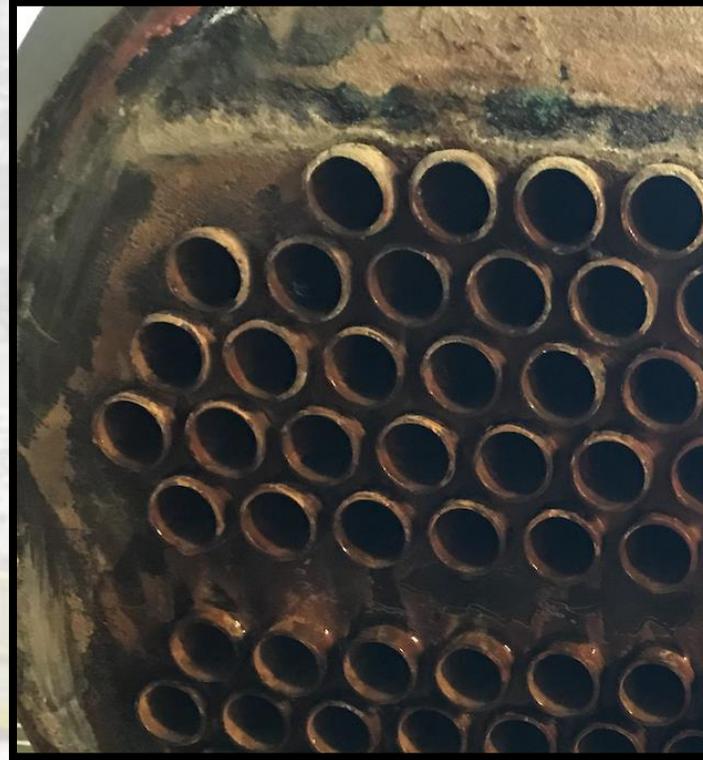
Both the cooling tower and dephlegmator, a specialized heat exchanger used in the distilling process, were experiencing scale buildup that was negatively affecting both temperature and flow rates that are critical to the process.

Hard limescale inside dephlegmator

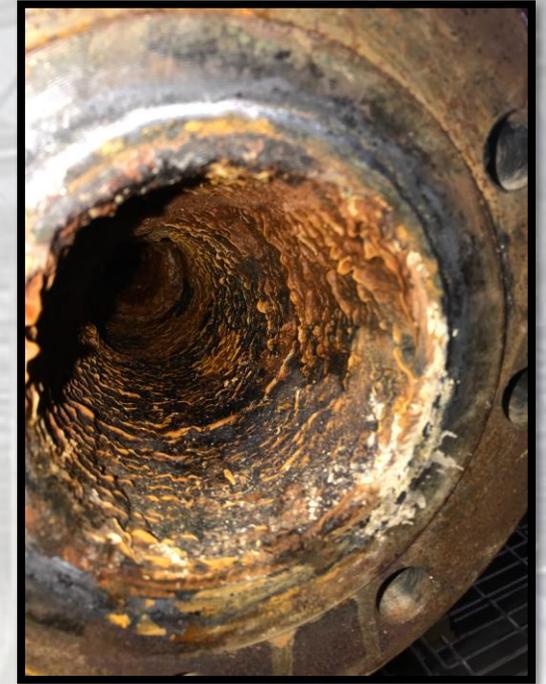
Limescale inside pipe

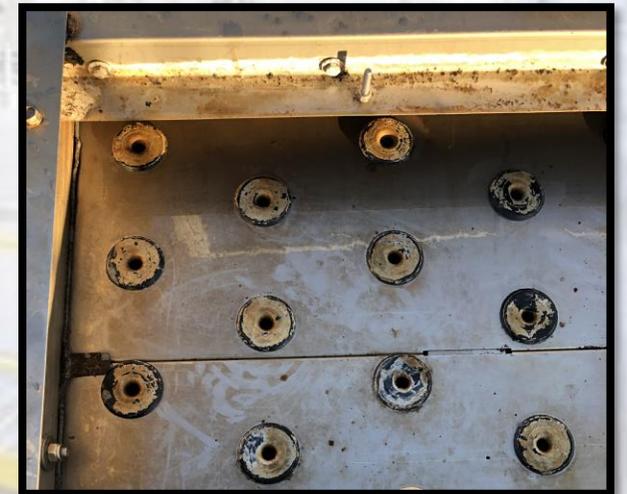
Limescale on cooling tower nozzles

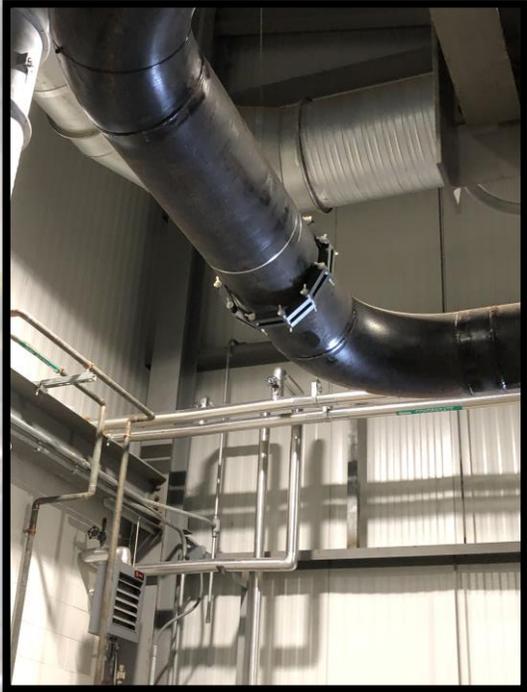
A *HydroFLOW* i12" Custom unit was installed on the cooling tower's recirculating loop in order to treat the entire system. The dephlegmator is located at the furthest point in the loop from the tower.

Installed *HydroFLOW* i12"

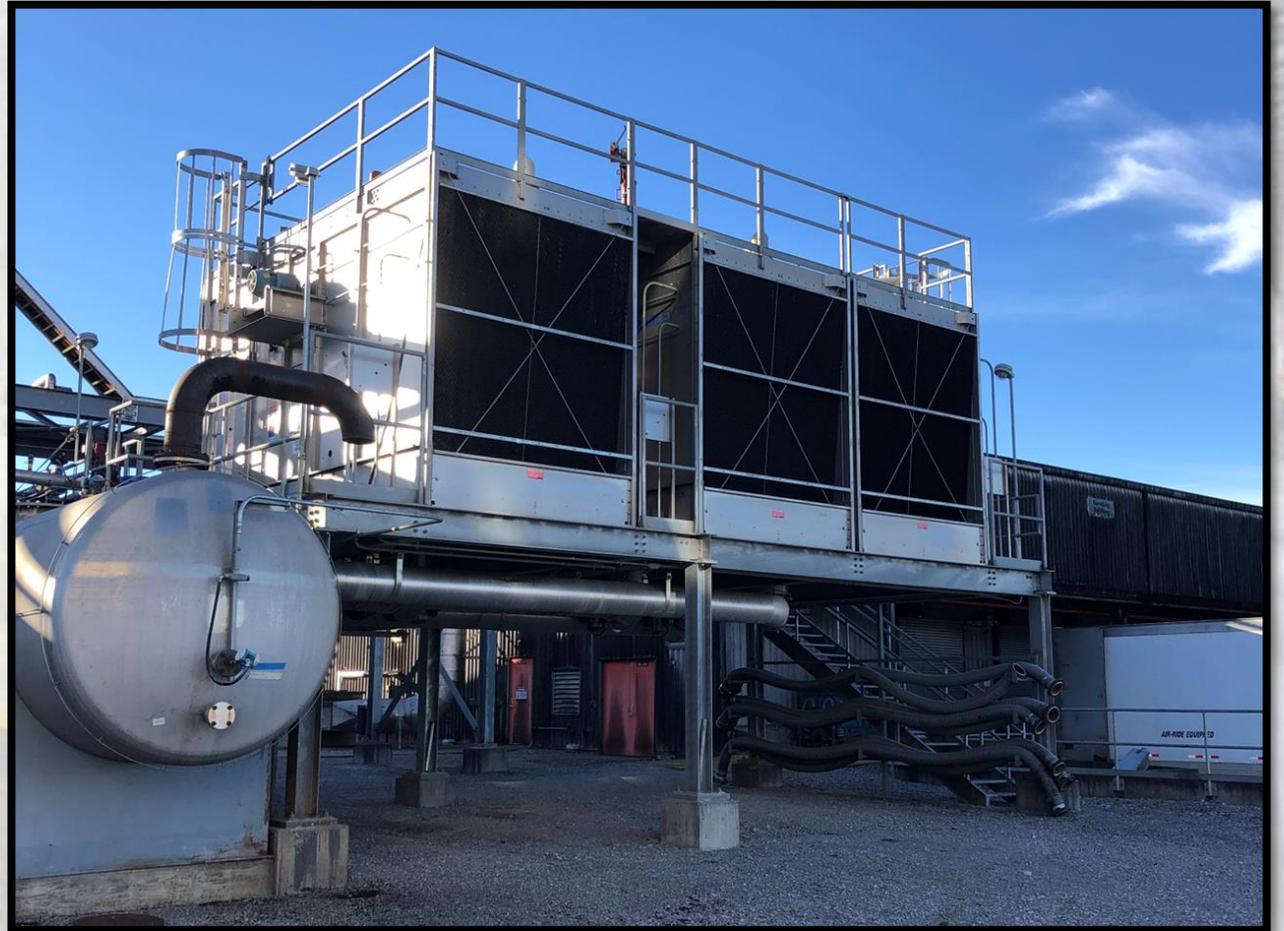
Distillery cooling tower

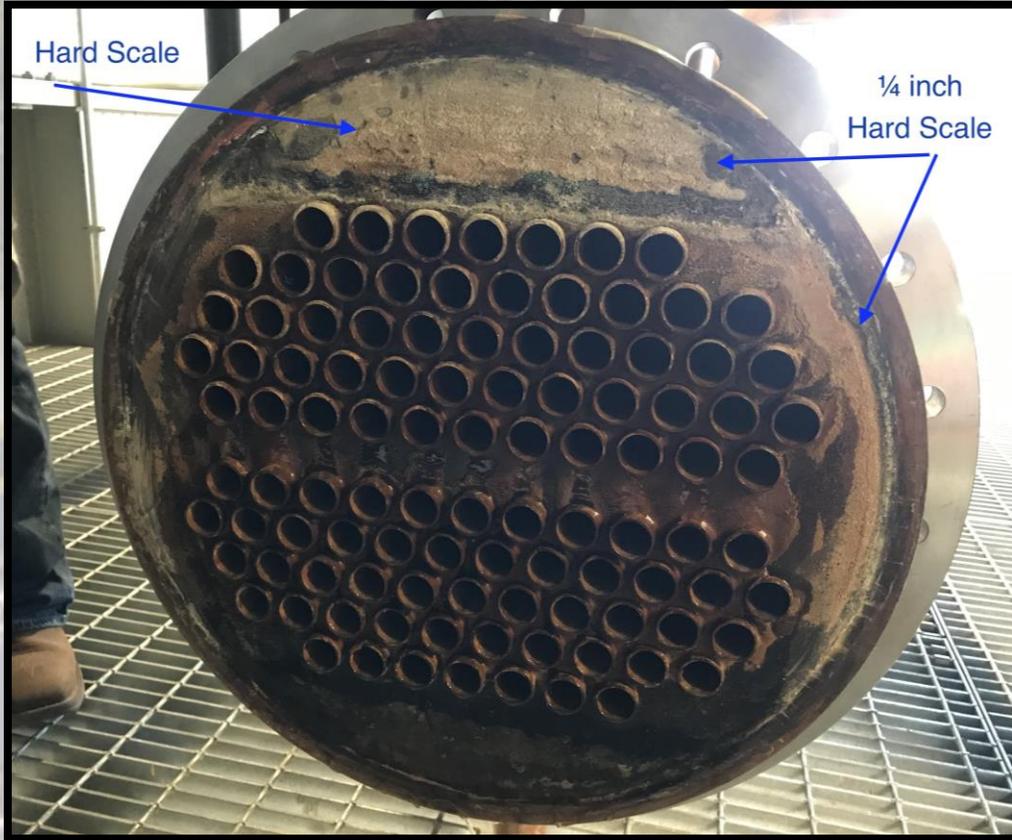
Before

Seven weeks after the installation of *HydroFLOW*, no new scale formed in the dephlegmator. Existing scale was “softer” and noticeably thinner.

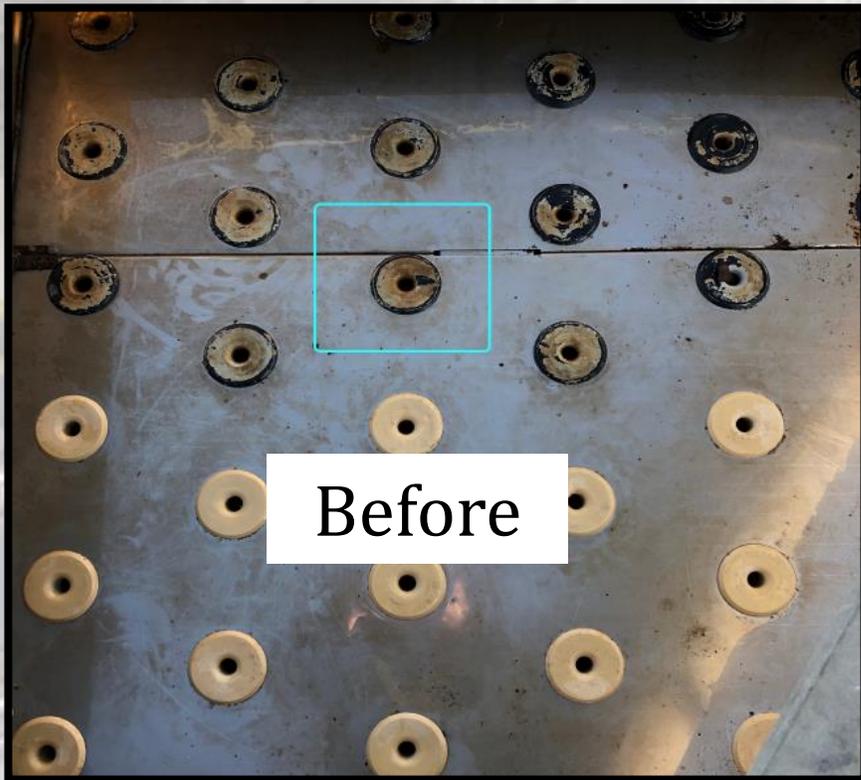
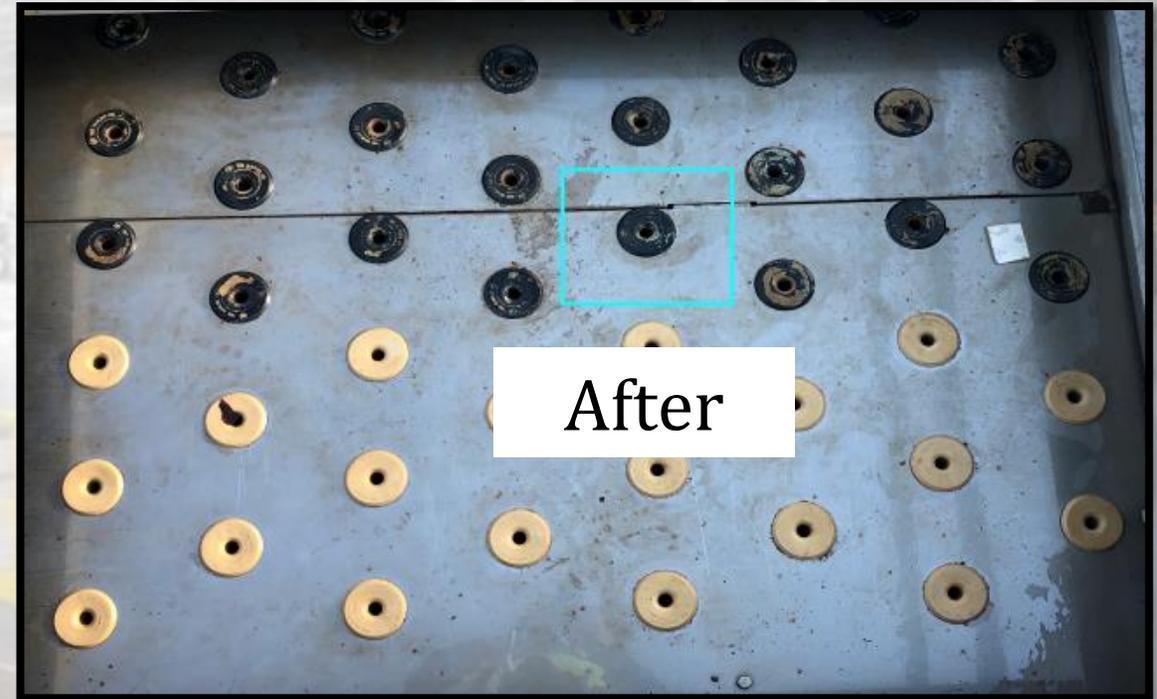
The tan nozzles were recently replaced because they were worn out, the black ones are original. After 6 months of run time, there would normally be hard scale on the nozzles. The black and tan nozzles both show no new scale. The black ones showed removal of existing scale. In addition, biofilm on infrastructure surfaces and in the recirculating water significantly decreased.
