GRAND HOTEL TERME DI COMANO HYDROFLOW C100 + P60 (x2)

CUSTOMER: GRAND HOTEL TERME of COMANO

APPLICATION: LEGIONELLA PREVENTION ON HOT WATER

ANTI-SCALING, ANTI BIOFILM AND LEGIONELLA PREVENTION TREATMENT IN HOT WATER SYSTEM

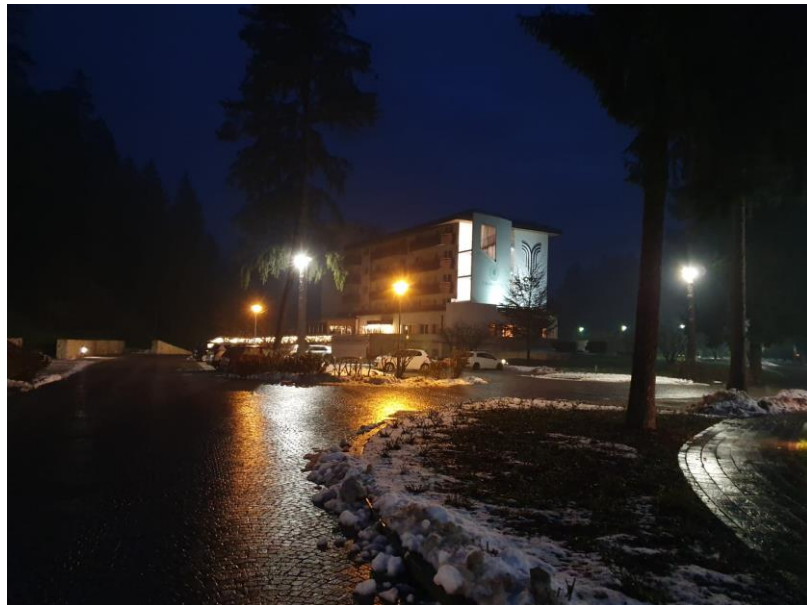
There were obvious signs of the presence of biofilm (organic / bacterial matrix) inside the pipes of the water network. This was evident in the light of the regular analyses. In various samplings, high Legionella contamination values were found (in the order of $10^3/10^4$ CFU / L), alternating with samplings within the bacteriological limits (up to 10^2 CFU / l). Even following sanitization interventions, the contamination was only temporarily reduced until proliferation re-occurred, as evidenced by another analysis above the limits.

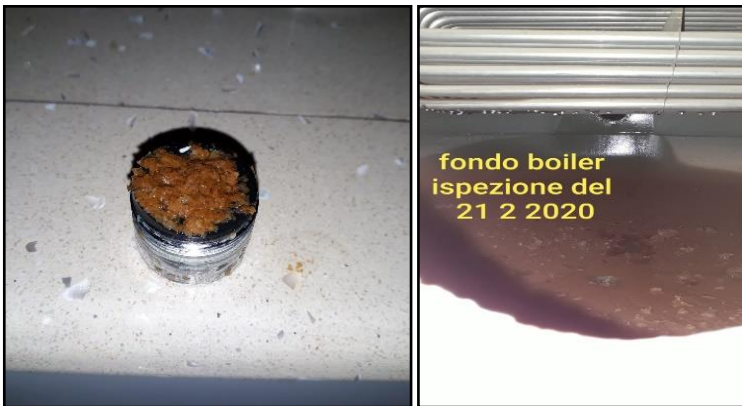
Photo 1, 2

(below photo report of the jet breaker and boiler bottom, index of internal cleaning of the system + summary table of the analytical values found)

DATE	DESCRIPTION	PHOTO	REFERENCE MICROBIOLOGICAL PARAMETERS
2018 -2019	Situation prior to treatment with Hydropath		Periodically levels of 10^3 CFU / L
02/21/2020	Initial process: closed structure cleaning with active DHW recirculation circuit ("concentration effect").	1, 2	$10^4/10^5$ CFU / L
Thermal Shock + Total purge + Reintegration			
03/04/2020	After Reintegration	3	$<10^1$ CFU / L
06/17/2020	Partial purge + make-up	4, 5	$<10^1$ CFU / L
