SUMMARY REPORT

on the results of testing Hydroflow Industrial (test) units on heat exchangers for cooling the distillate of the Zaporizhzhya Nuclear Power Plant (ZNPP, Ukraine)

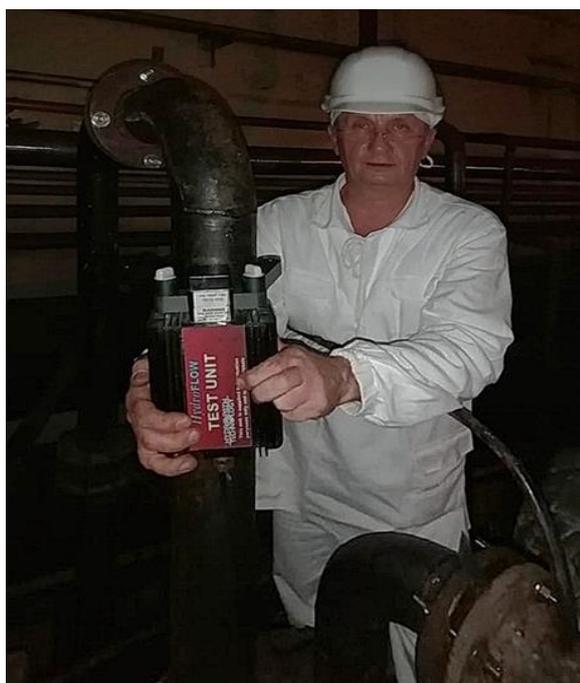
Before the beginning of the test installations both heat exchangers were opened for inspection of their initial condition, application of control “beacons” and selection of control samples of deposits, which were examined in a local certified laboratory.

The condition of the internal surfaces of the heat exchanger tubes was also examined with photo and video fixation using “TESLONG” digital endoscope. Snails *Melanoides tuberculata* were discovered on silty deposits inside several heat exchange tubes. The tubes were filled with sludge so much that it was impossible to immerse the endoscope probe into them to a depth of more than 0.5 m

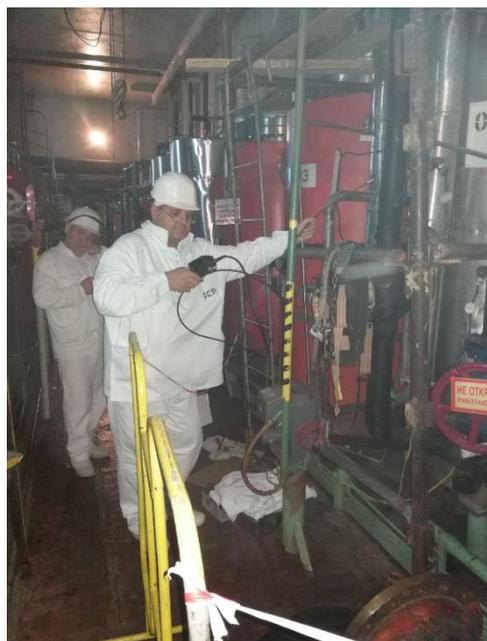
- Extreme (decrease by 3.65 times), confirmed by laboratory analysis, leaching of carbonates from the structure of deposits, a significant increase in brittleness, decrease in hardness and size of very hard complex deposits existed at the beginning of test installation;
- Complete blocking of the formation of new deposits on the applied special "beacons";
- Complete removal of biological deposits, which are the nutrient base for snails;

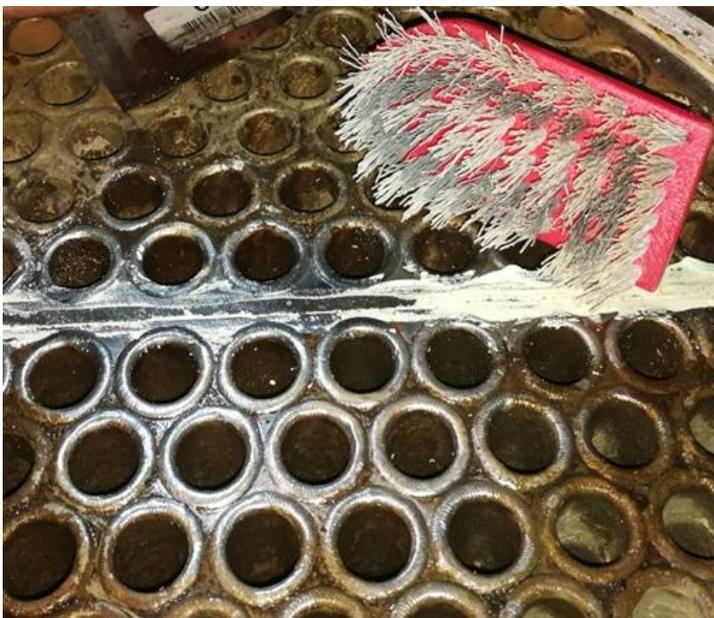
*Tube board cleaning
using household plastic brush*

- The practical possibility of removing, with the help of a household plastic brush, a thin powder layer formed on the surfaces of the “beacons”. This powder layer consists of carbonate microcrystals washed out from complex deposits and has minimal adhesion to stainless metal;

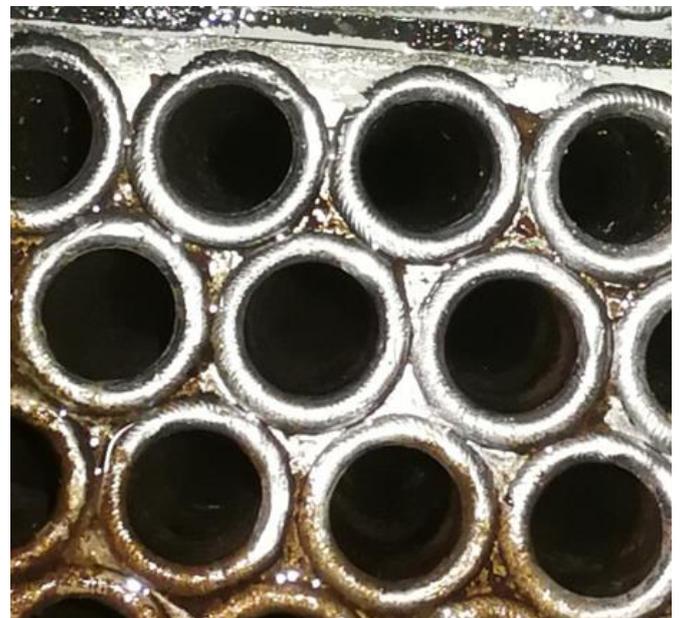
*Cleaned “beacons” on the pipe
using household plastic brush*

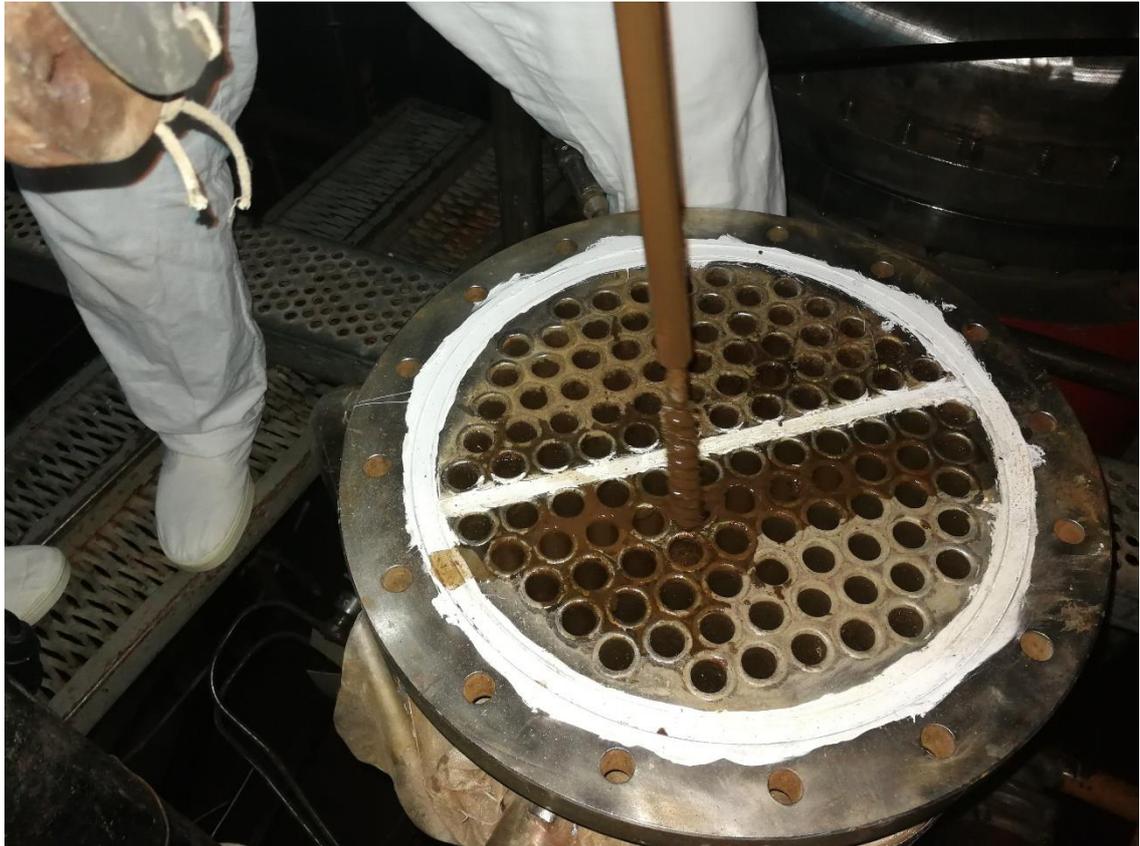
Cleaning the heat exchanger tubes with a steel wool

- Changing of the structure and softening of the carbonate structures present on the walls of the heat exchanger tubes and evidence of the possibility, in practice, of their removal using a conventional steel wool;
- Blocking the formation of new carbonate deposits on the walls of the tubes;
- Easy removal of silt structures from the walls of the tubes using a conventional plastic brush;
- Complete removal of biological deposits with a characteristic color, mucous texture and putrefactive odor, which were recorded at the beginning of the test installation;

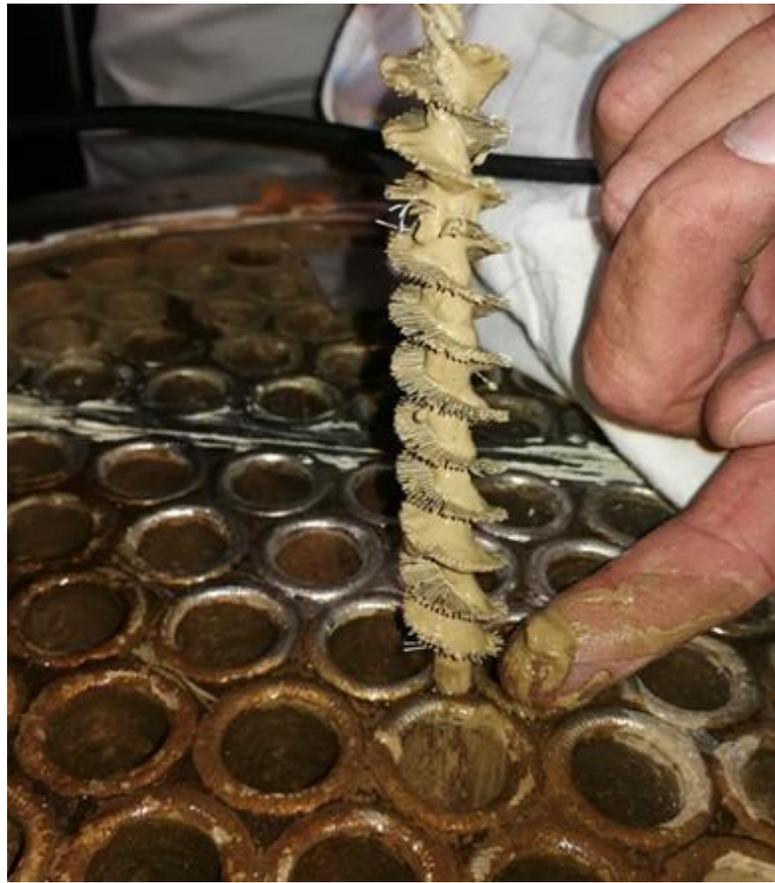
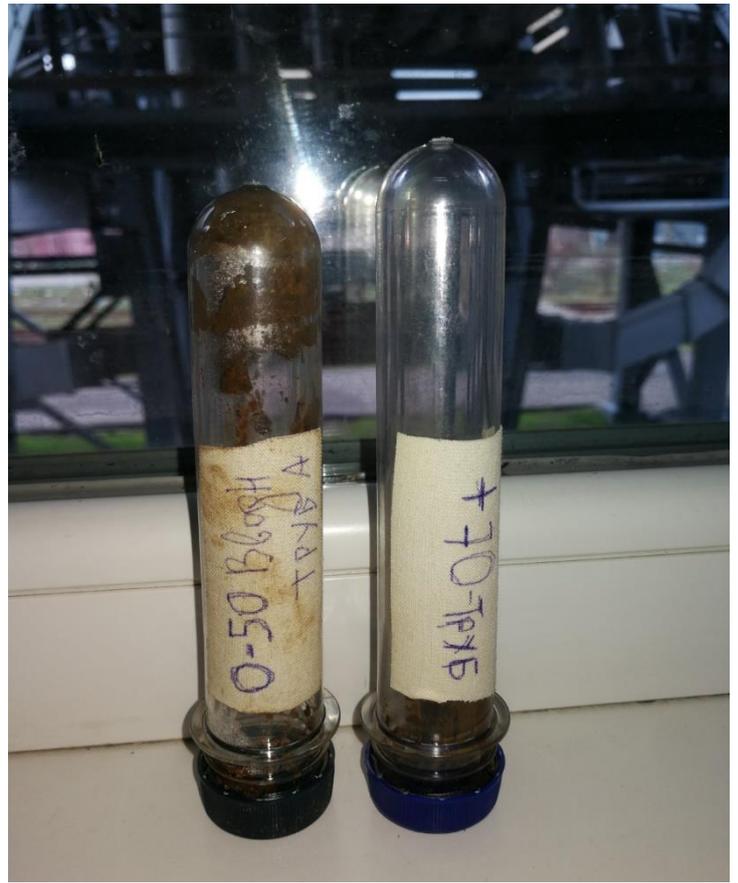
Sampling deposits from the inner surface of the wall of the heat transfer tube

Using “TESLONG” endoscope the condition of the inner surfaces of the heat exchange tubes and their test treatment areas with the help of a steel wool was examined. Also during the final opening the samples of deposits from inner surfaces were taken and transferred to the laboratory for analysis.
