HydroFLOW Case Study - Texas Hotel

Potable hot water system - Limescale reduction

January 2023

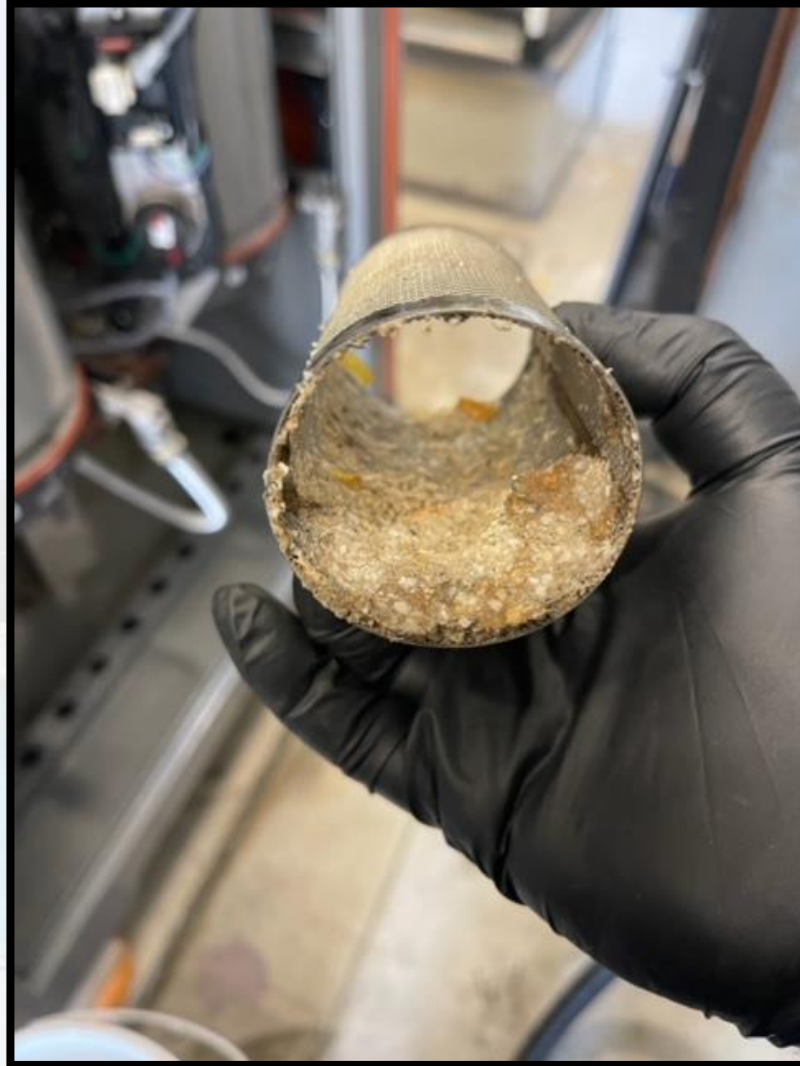
Hard limescale in the water heater's strainer

San Antonio has extremely hard water of 357 PPM (21 GPG).

Prior to the installation of two *HydroFLOW i100* units, the hotel was forced to provide discounts on rooms, and in some cases full refunds, due to very low water pressure and lack of hot water.

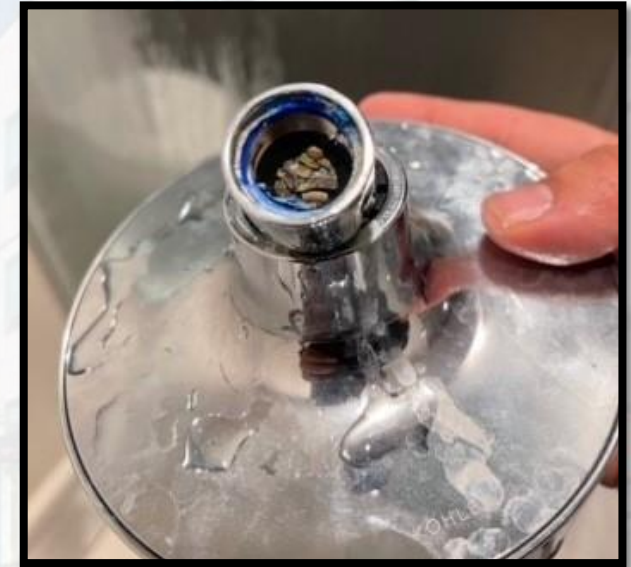
Limescale chunks in showerhead

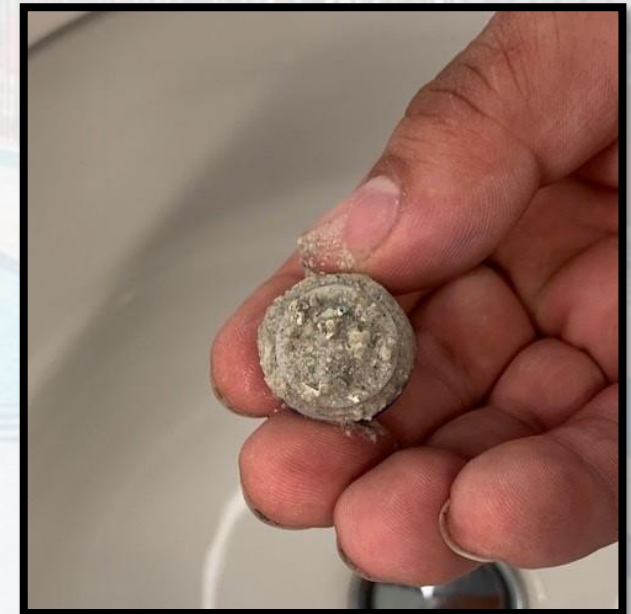
Plugged-up a faucet aerator

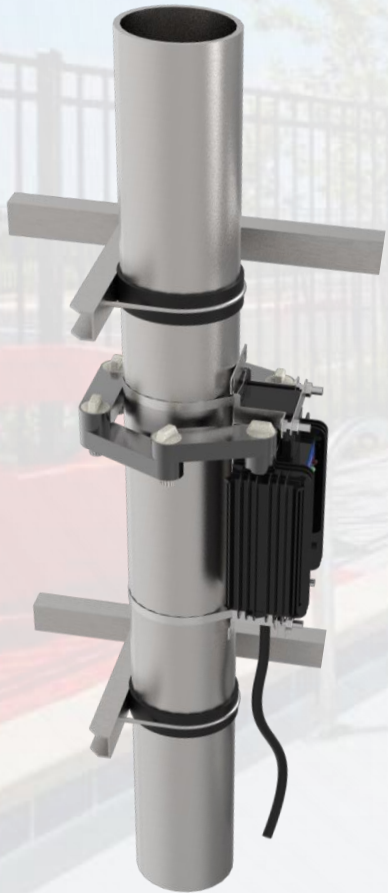
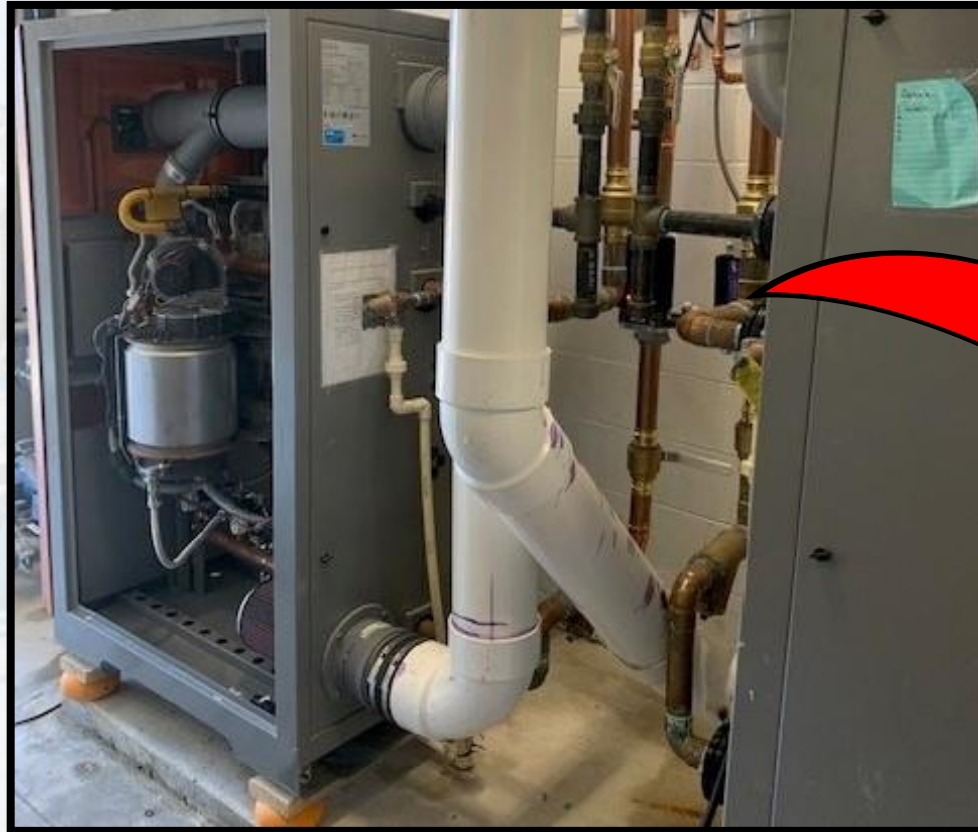
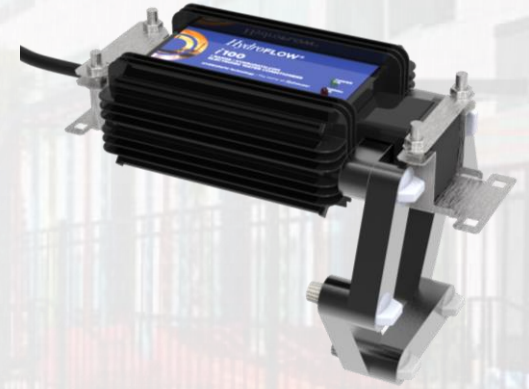
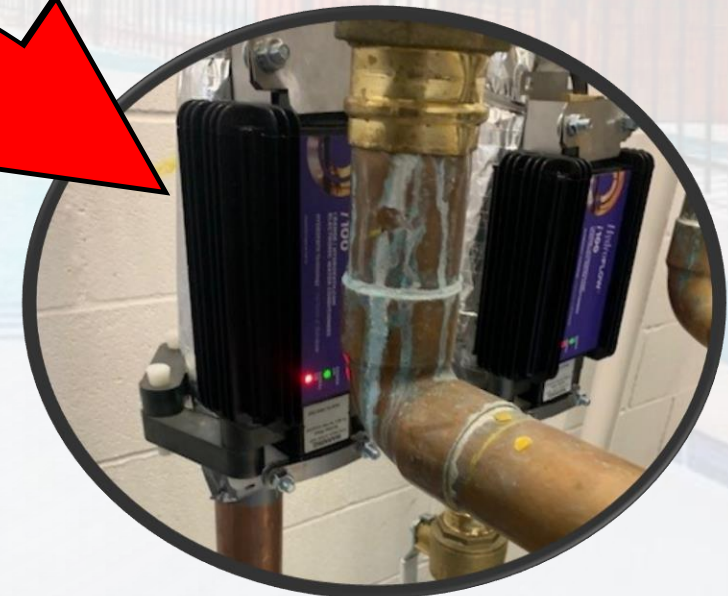
Tankless water heaters and *HydroFLOW* devices

In the beginning of 2022, ECO HydroFlow (<https://www.ecoiti.com/hydroflow/>) installed two i100 *HydroFLOW* water conditioners on the main water lines feeding the hotel's tankless water heaters.

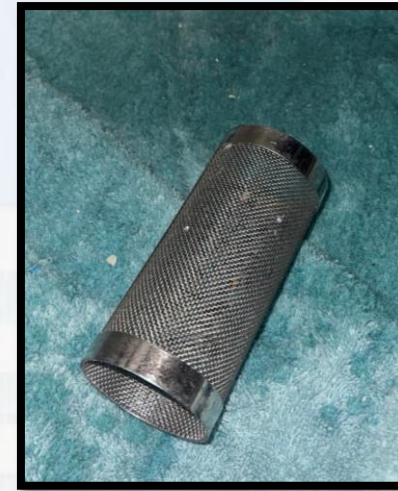
Clean strainer during routine maintenance

- A few days after the installation, “soft” scale began to purge out of the hot water system.
- One month after the installation, flow rates started to drastically improve; alarms that would sound weekly due to low flow rates, are very rarely heard.
- Previously clogged showerheads and faucet aerators have minimal debris.
- Cleaning the tankless water heaters is 75% less frequent and much easier; harsh chemicals are no longer required.
- Twelve months after installation, the estimated return on investment (ROI) is well under a year.
- An added benefit is *HydroFLOW*'s ability to deactivate pathogens such as *E. coli* and *Legionella* and remove biofilm from water systems.

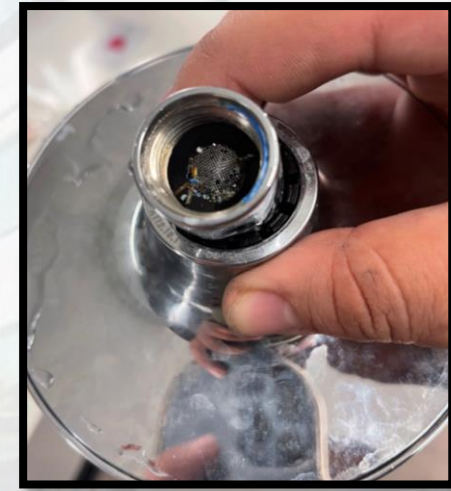
Showerhead with a little debris

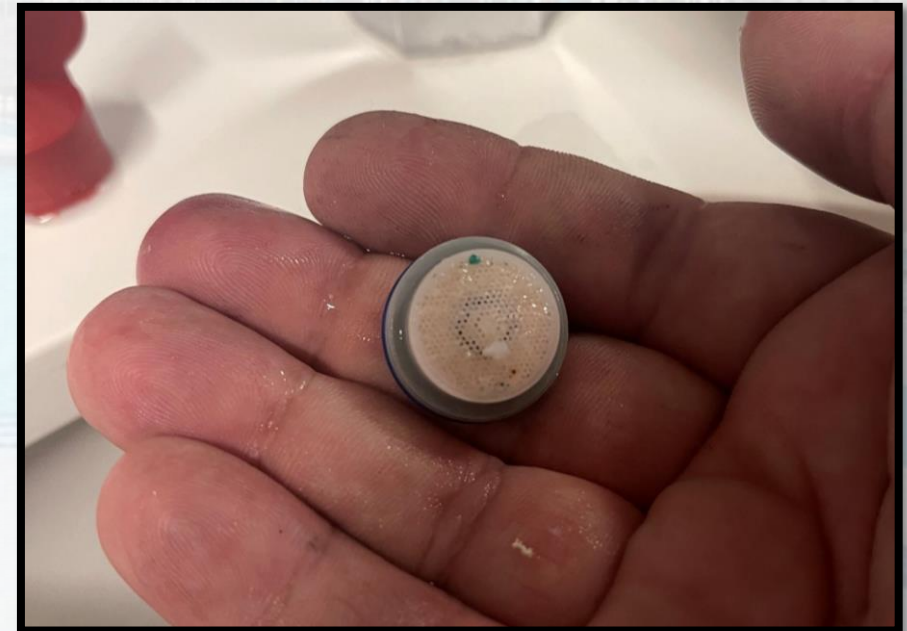
Faucet aerator with negligible debris
