Cobb County, Georgia

Mountain View Aquatic Center

Alternative To Ultra-Violet (UV) Water Treatment

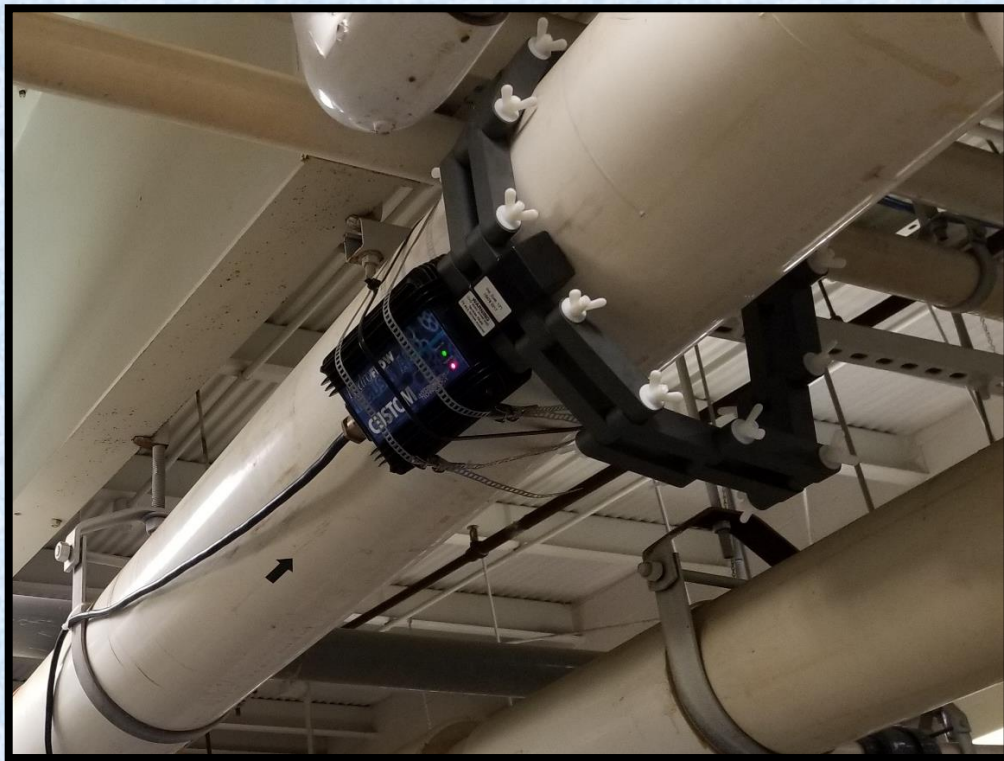
Installed *HydroFLOW* device

Upon installation, the Hydropath signal began to propagate throughout the recirculating pool system. Clear signal readings were observed at the surge tank, the pool, the filters and the heat exchanger.

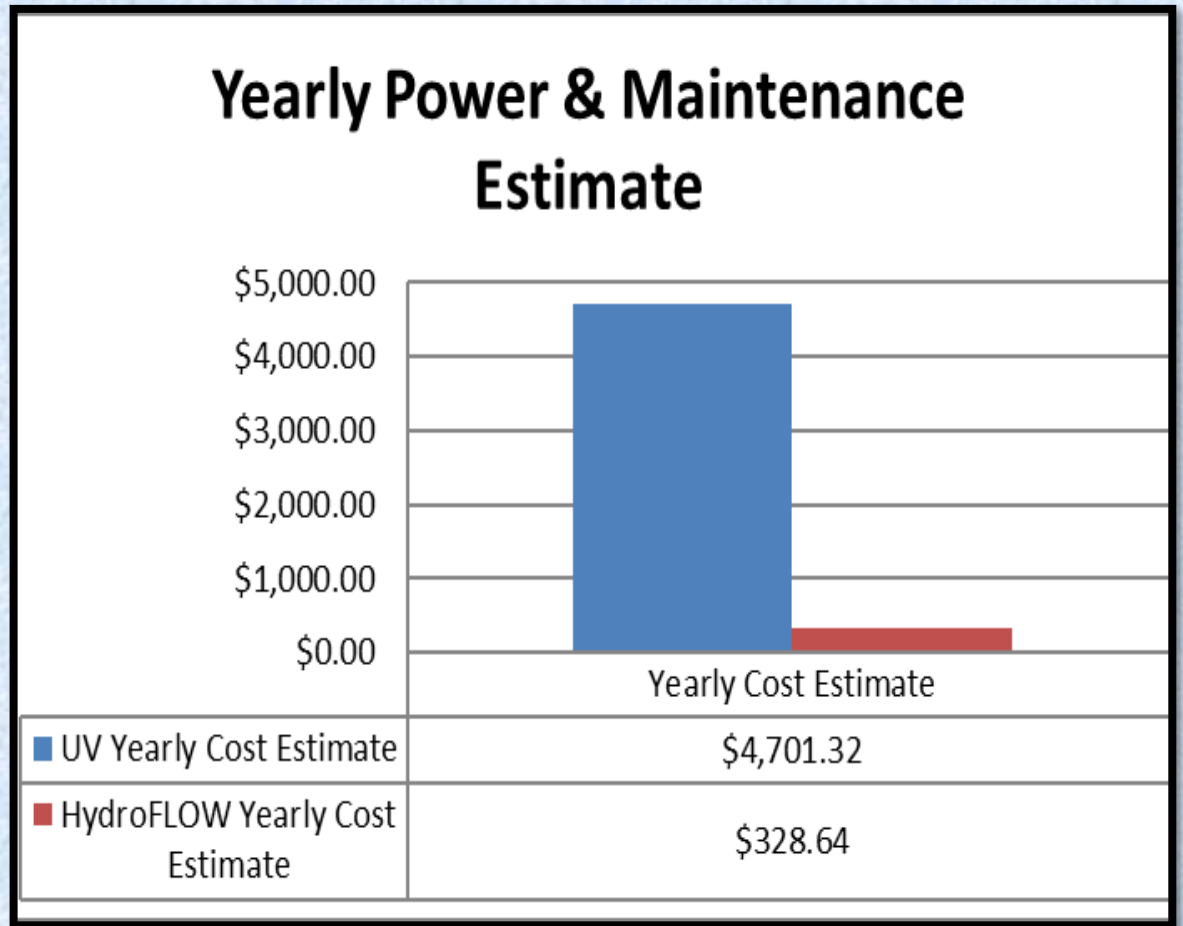
The trial showed the more economical *HydroFLOW* water conditioner achieved similar or better air quality results (reduced chloramines) compared to the UV system, at a fraction of the ongoing maintenance cost. In addition, there was a noticeable downward trend in backwash times, chlorine usage and scale accumulation in the heat exchanger. Empirical data to support the results is available upon request. Results can also be verified with the Cobb County Aquatic Manager.
